TECHNICAL MEMORANDUM
CULTURAL RESOURCE ASSESSMENT SURVEY
IN SUPPORT OF THE STATE ROAD 87 CONNECTOR,
SANTA ROSA COUNTY, FLORIDA

CONSULTANT:	SEARCH 700 N. 9 th Street, Pensacola, Florida 32501
PRINCIPAL INVESTIGATOR:	Elizabeth J. Chambless, MS, RPA
PROJECT ARCHAEOLOGIST:	Jessica Fish, M.St., RPA
CLIENT:	FDOT District 3
DATE:	September 2015
FM#:	416748-3, 416748-4

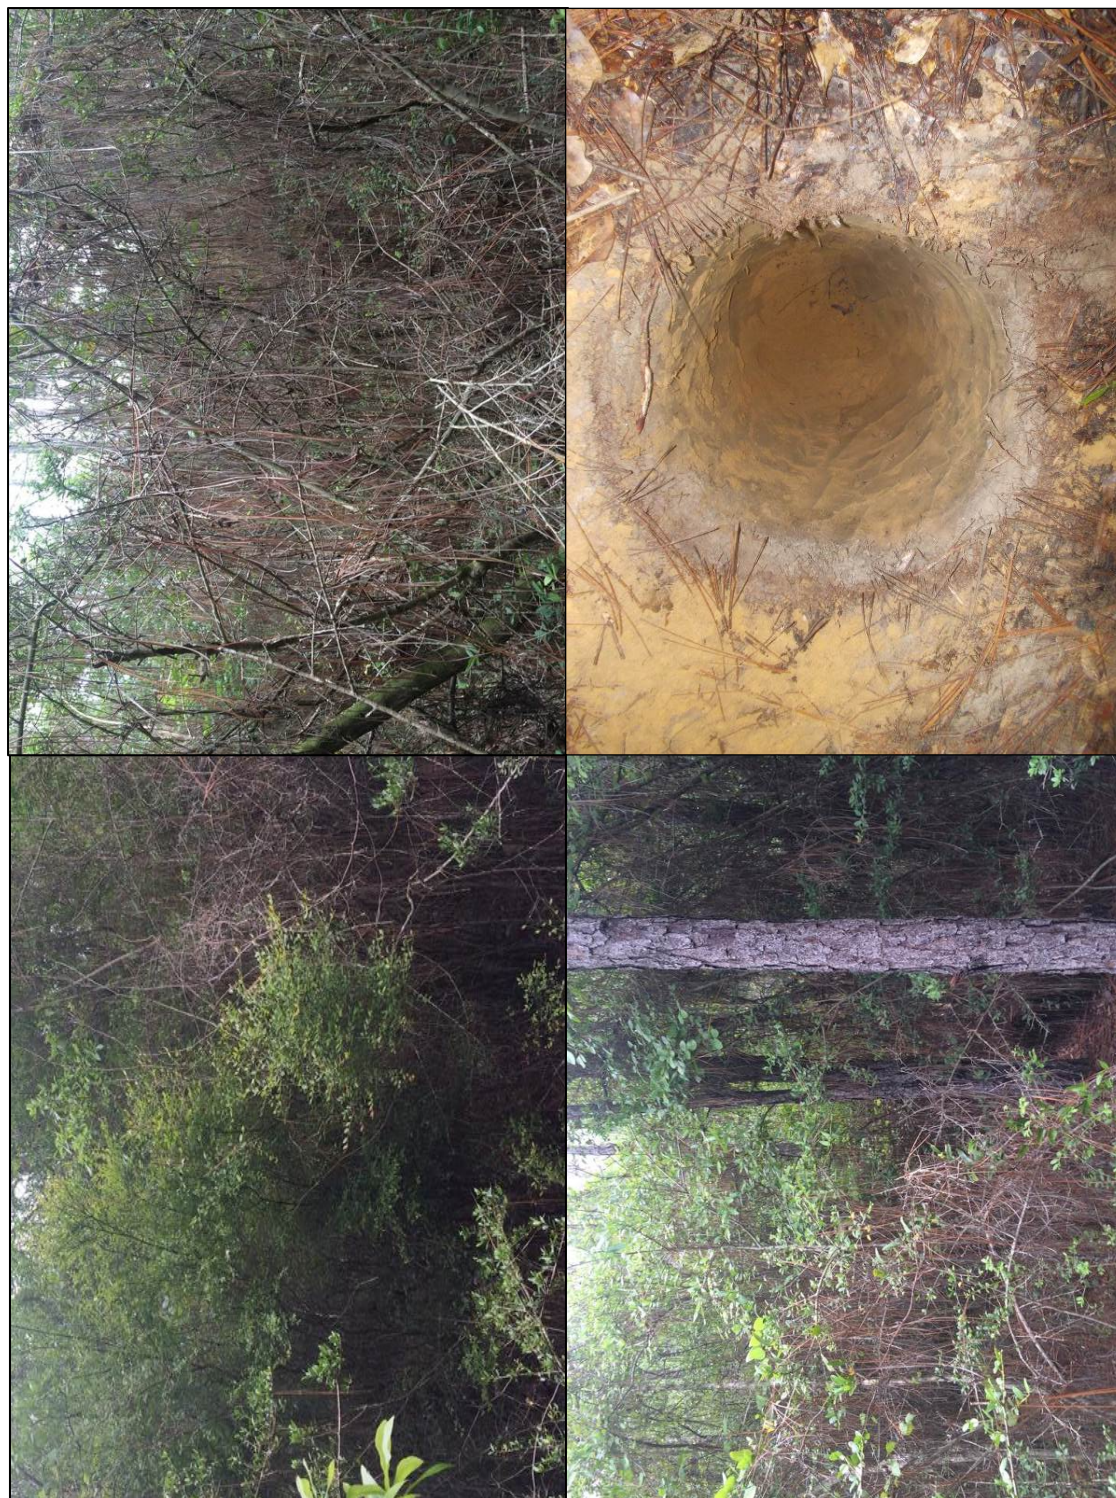
Figure 5. Top right: Overview of right-of-way within high-probability area east of SR 87, view east. Top left: Overview of planted pine forest, view north. Bottom left: Overview of right-of-way west of SR 87, view west. Bottom right: Typical soil profile for shovel tests in the SR 87 Alt 2 right-of-way.

A typical soil profile began with 10 to 40 centimeters (4 to 16 inches) of light gray or gray-brown coarse sand. A second stratum of yellow-brown coarse sand was next encountered to a depth of 90 to 100 centimeters (35 to 39 inches). In some cases, a third stratum of light yellow sand was identified below this (see **Figure 5**). Excavation of shovel tests typically terminated at approximately 100 centimeters below surface (cmbs) (39 inches).

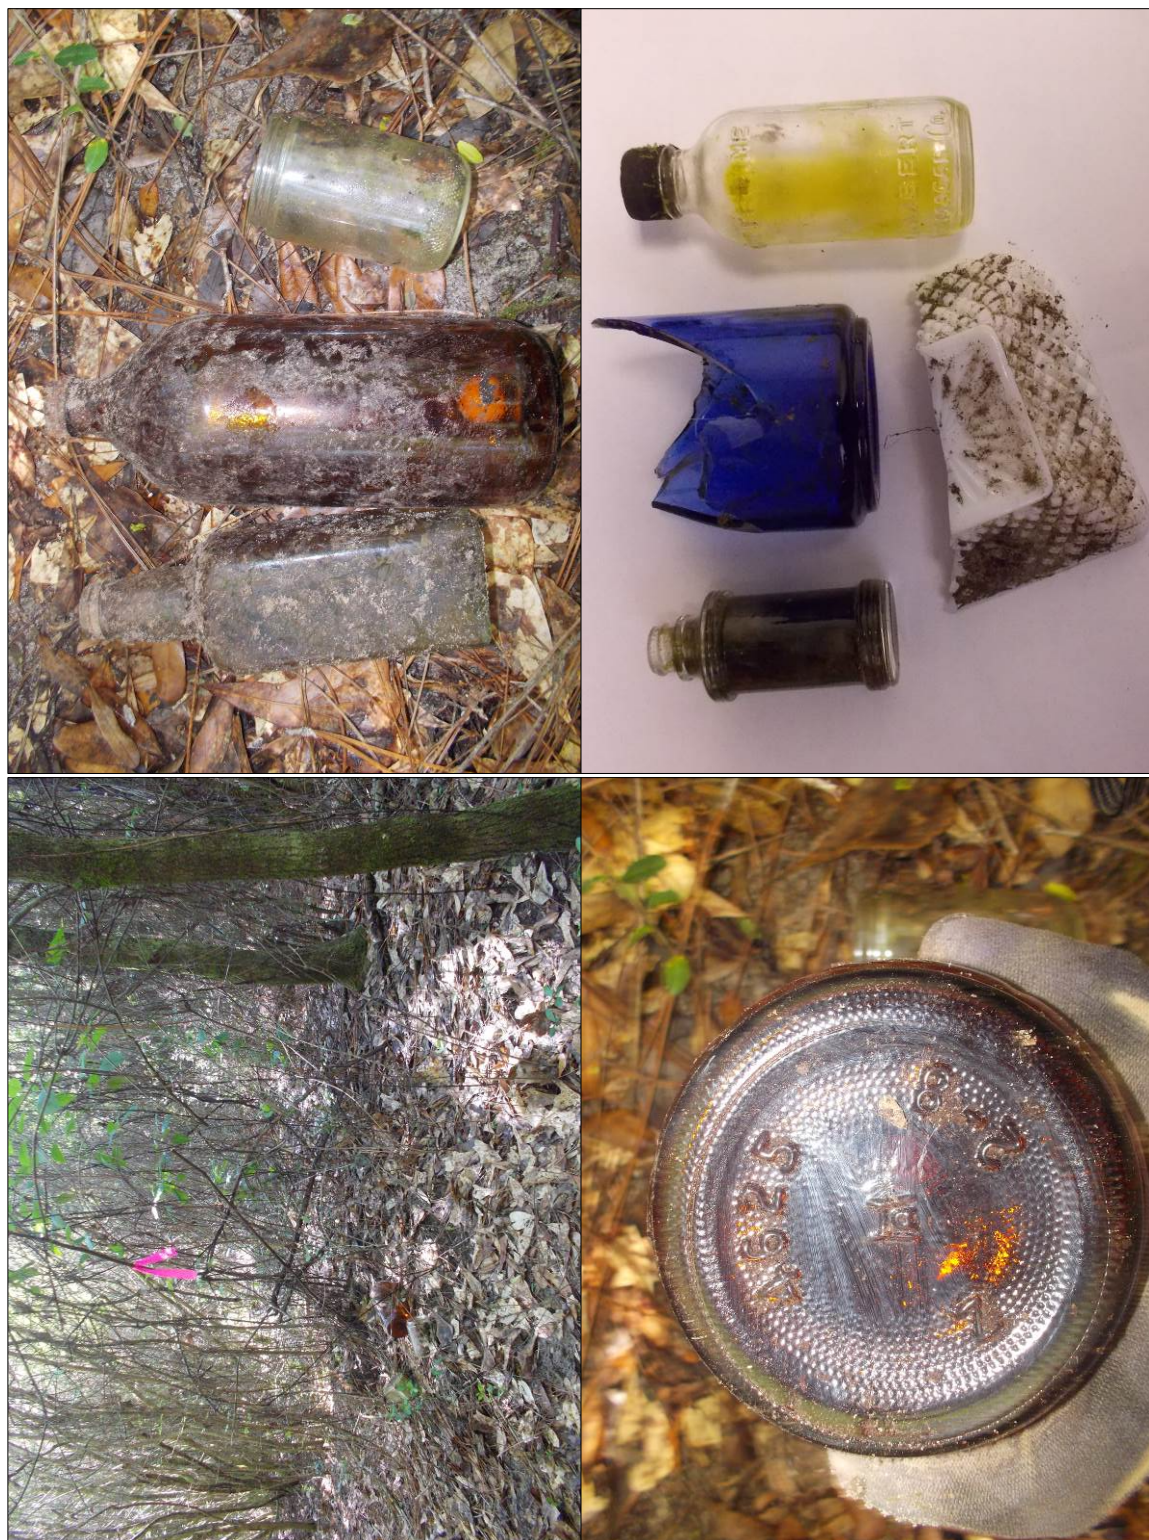
Figure 6. Top left: Overview of 8SR02200. Top right: Sample of surface finds at 8SR02200. Bottom left: Hazel-Atlas bottle mark, dated post-1923. Bottom right: Contents of Field Bag 001.

Archaeologists noted several historic artifacts on the ground surface, including metal fragments, metal cans, and glass bottle fragments. A sample of glass fragments was collected, and these are presented in the FS log in **Attachment B**. These included a milk glass ash tray with pressed glass decoration, a cobalt blue Vick's Vaporub bottle (post-1890s), a square bottle likely manufactured by Keystone Glass Works (late nineteenth century to early twentieth century), an amber bottle manufactured by the Hazel-Atlas Company (post-1923) and a Listerine bottle produced by the Diamond Glass Company (1924-ca. 1940) (**Figure 6**) (Lindsey 2015; Proctor & Gamble 2015). These artifacts suggest a late-nineteenth to early-twentieth century date. The domestic nature of the artifacts (e.g., medicine bottles, ash tray) may indicate the presence of a nearby residence, as opposed to a turpentine distillery or other commercial enterprise. Pedestrian survey revealed no evidence for a structure (e.g., bricks) in the immediate vicinity of the surface scatter.
